5.0 POST LAUNCH PAD DEBRIS INSPECTION

The post launch inspection of the MLP, Pad A FSS and RSS was conducted on 19 May 2000 from Launch + 2 to 4 hours. No flight hardware was found.

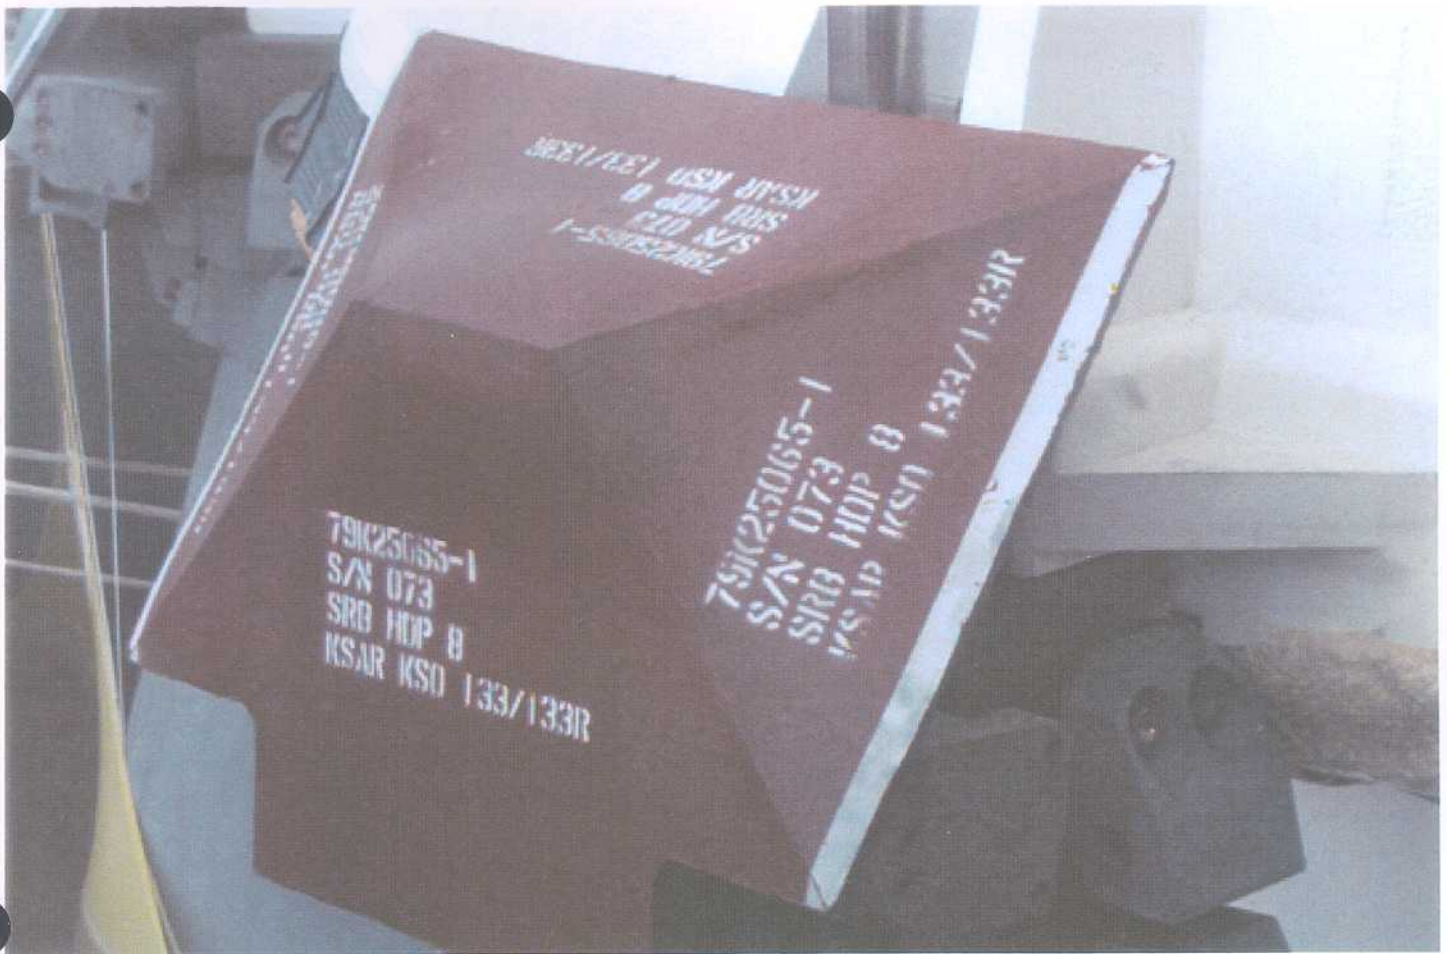
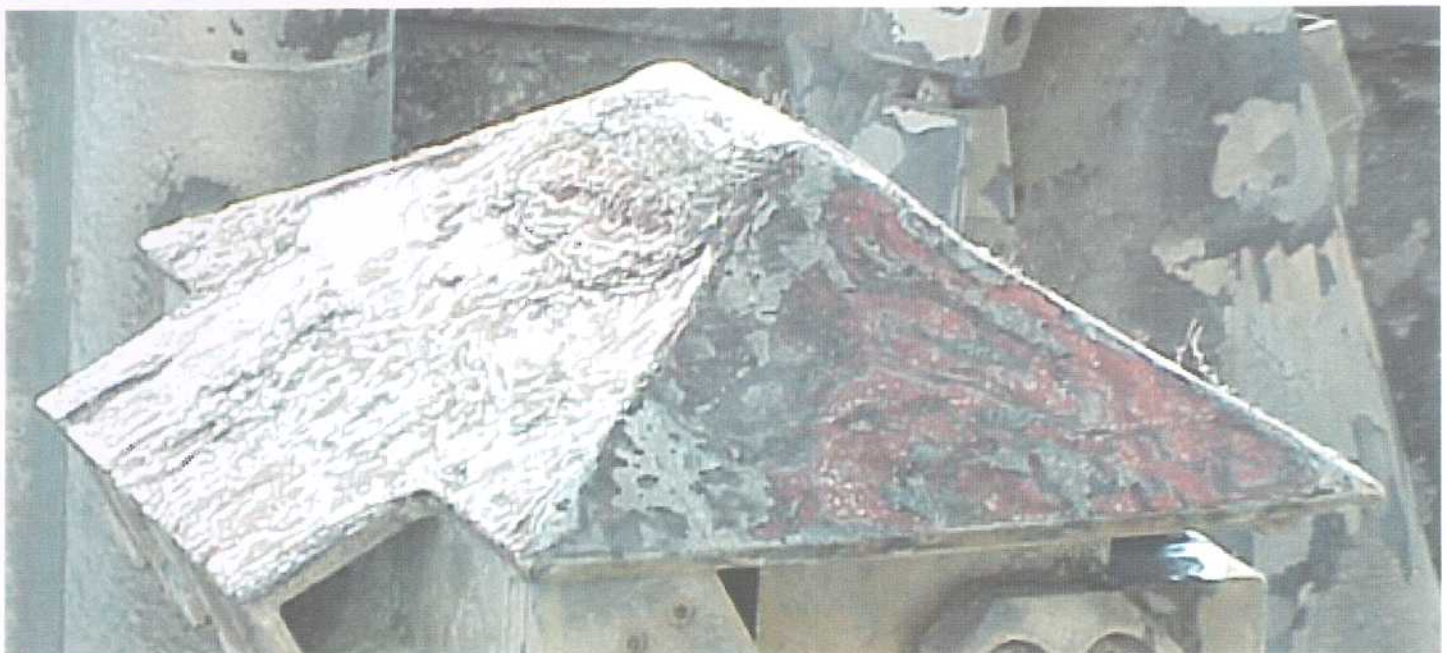
Photo 11: HDP #8 Blast Cover Coating

The blast cover for HDP #8 was modified with an ablative test coating material to protect the steel cover from SRB plume erosion. The material ablated as designed with no apparent damage to the steel cover.

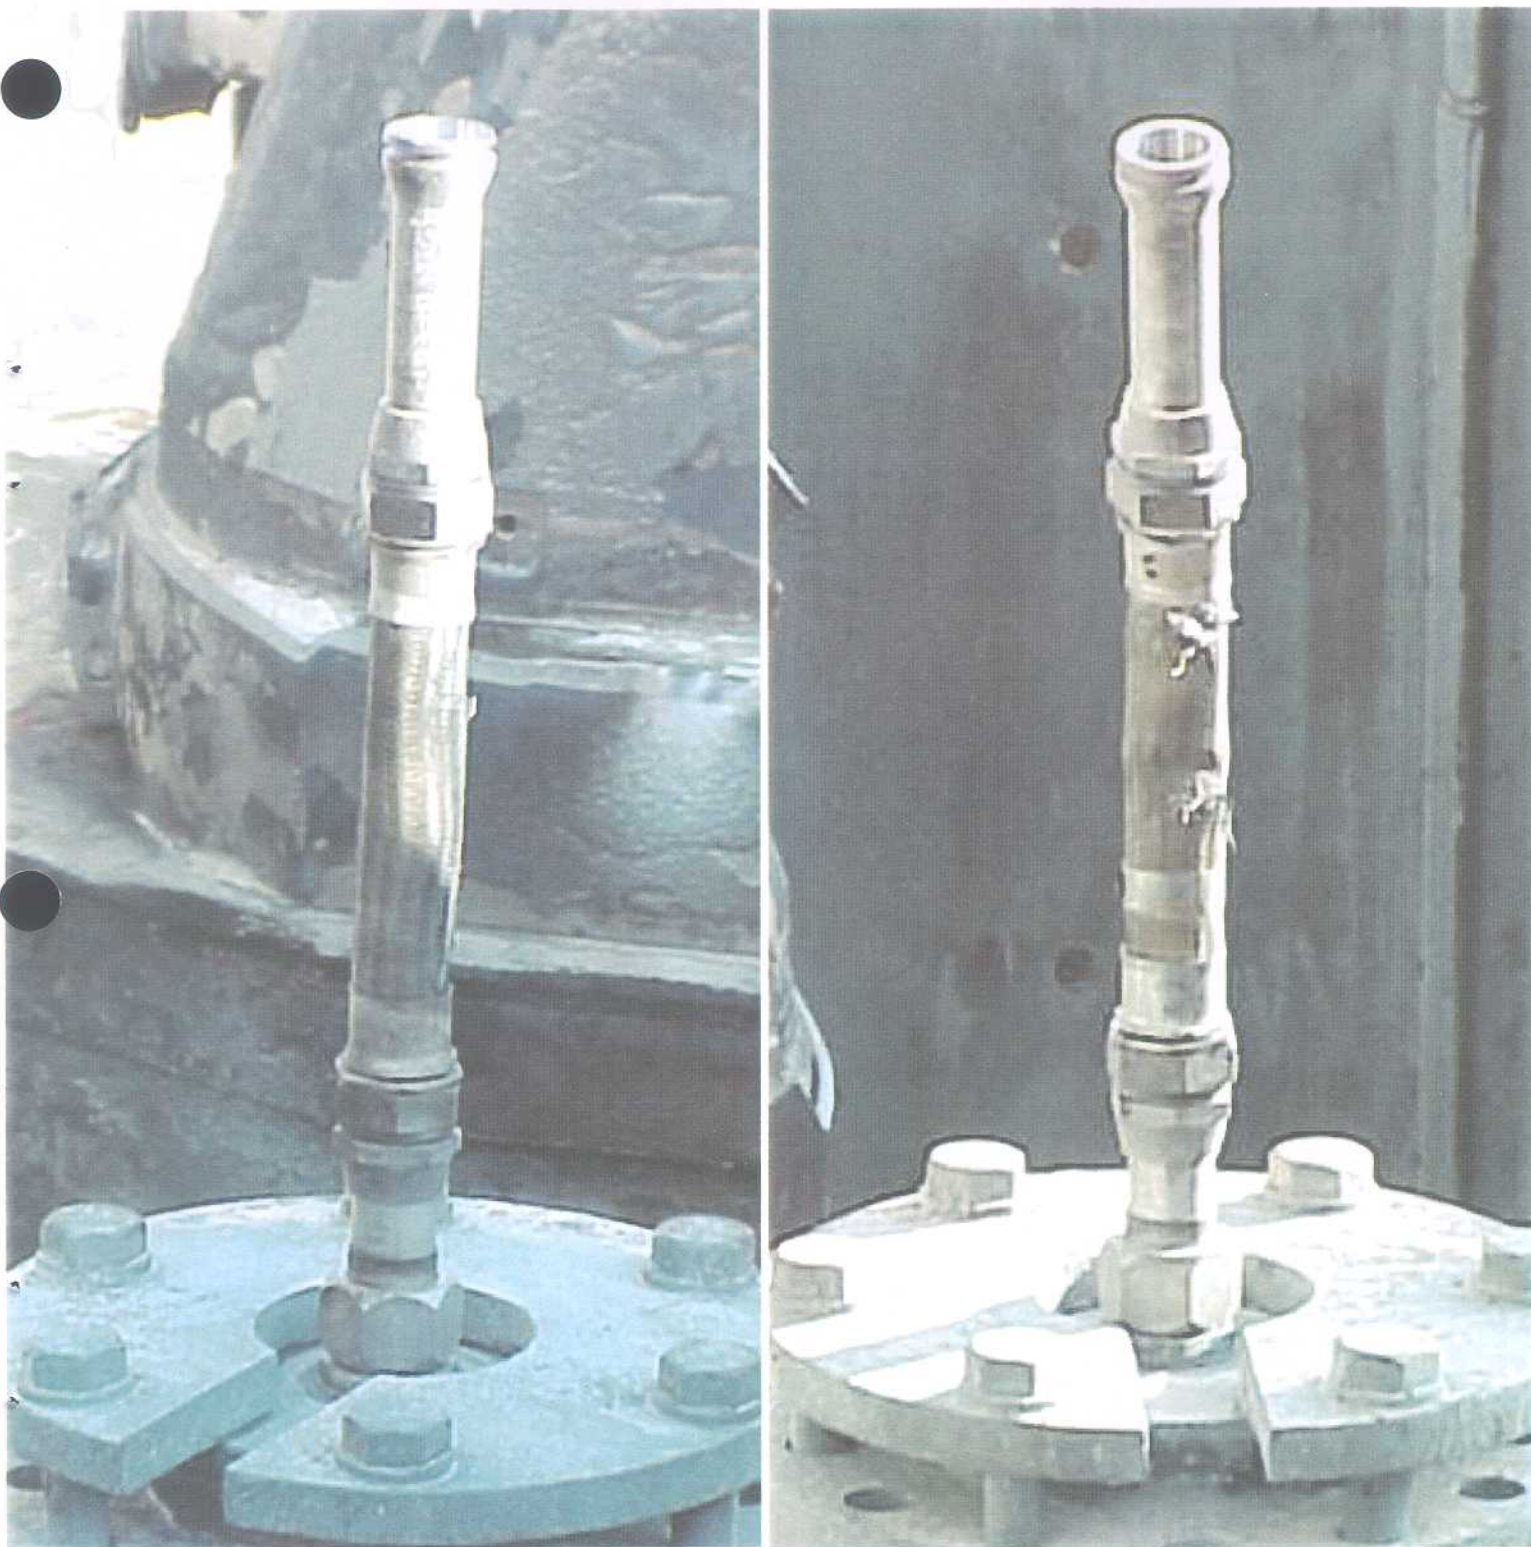
Photo 12: Aft Skirt GN2 Purge Lines

Both SRB aft skirt GN2 purge lines were intact, though the protective tape was almost entirely eroded away with minimal damage to the underlying braided shield.
